**Flood Control Project Maintenance
Levee Inspections****2011 Channel Summary Report****Overall Unit and Item Ratings****Adin Community Service District**

Flood Control Project Maintenance**Unit Cover Sheet****2011 Channel Inspection Results****Adin Community Service District**

Channel
Ash Creek

Channel Rating	A
Date of Inspection	7/13/2011
DWR Inspector	Bob Duffey
Accompanied By	Mike Williams Adin Community Service District

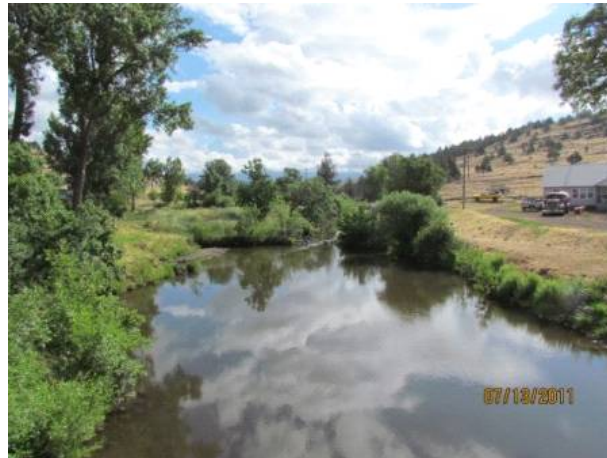
Levee Mile Report Line	1
Start Levee Mile	0.00
End Levee Mile	0.00
Location	
Category	Channels
Item	Vegetation & Obstructions
View from Main Street (Highway 299) towards the gauging station.	
rduffey_c_20110726_021.jpg

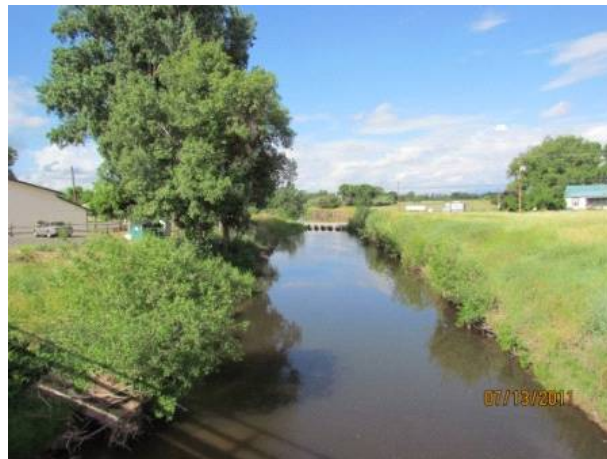
Levee Mile Report Line	6
Start Levee Mile	0.00
End Levee Mile	0.00
Location	
Category	Channels
Item	Vegetation & Obstructions
View from Main Street (Highway 299) towards the Ash St. low water crossing.	
rduffey_c_20110726_022.jpg

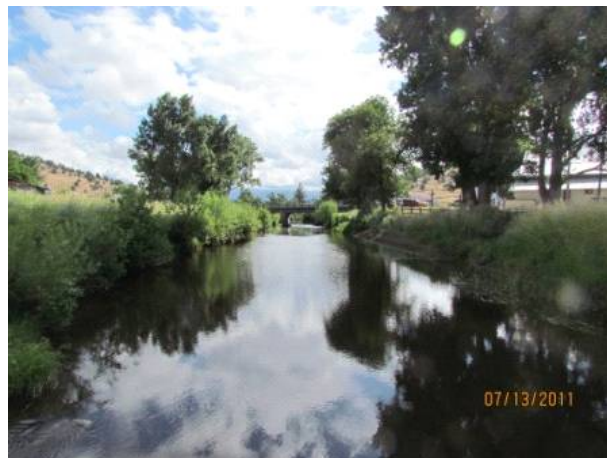
Levee Mile Report Line	11
Start Levee Mile	0.00
End Levee Mile	0.00
Location	
Category	Channels
Item	Vegetation & Obstructions
View of the channel from Ash Street low water crossing.	
rduffey_c_20110726_023.jpg

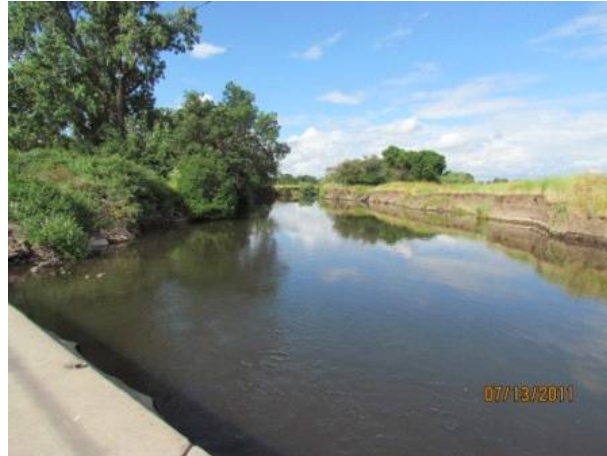
Levee Mile Report Line	18
Start Levee Mile	0.00
End Levee Mile	0.00
Location	
Category	Channels
Item	Erosion / Bank Caving

View of the moderate erosion on both banks.

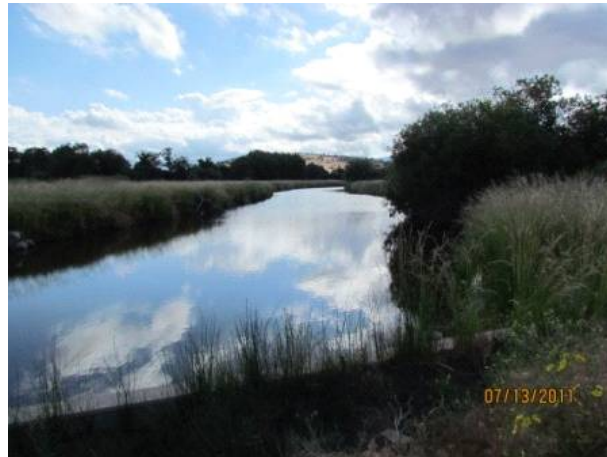
Levee Mile Report Line	21
Start Levee Mile	0.00
End Levee Mile	0.00
Location	
Category	Channels
Item	Vegetation & Obstructions

View of the upstream side of the weir.

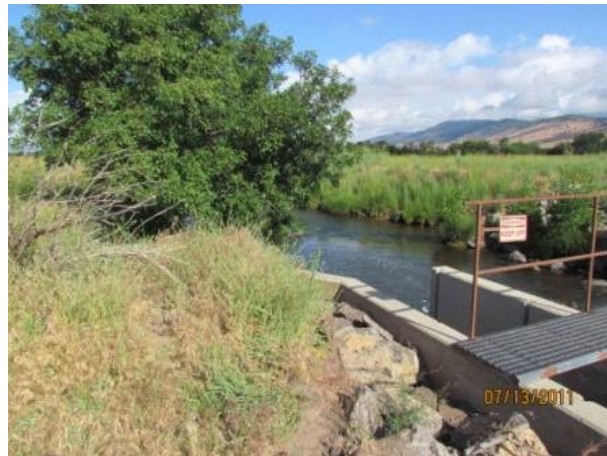
Levee Mile Report Line	26
Start Levee Mile	0.00
End Levee Mile	0.00
Location	
Category	Channels
Item	Vegetation & Obstructions

View of the downstream side of the dam & fish ladder constructed by Dept. of Fish & Game in October 1999.

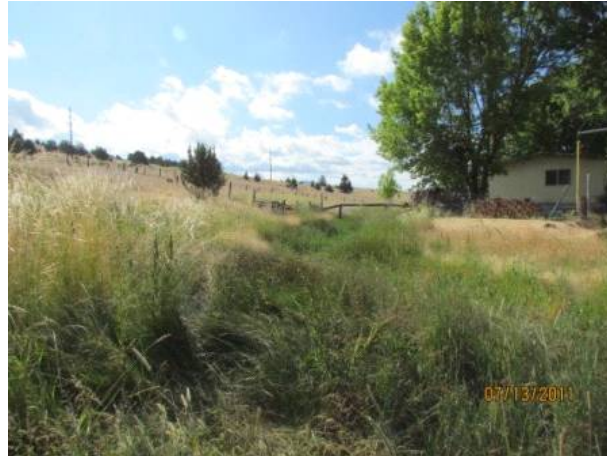
Levee Mile Report Line	1
Start Levee Mile	0.00
End Levee Mile	0.00
Location	
Category	Channels
Item	Vegetation & Obstructions
Upstream at Adin Street. Minimal growth in channel.	
rduffey_c_20110801_037.jpg

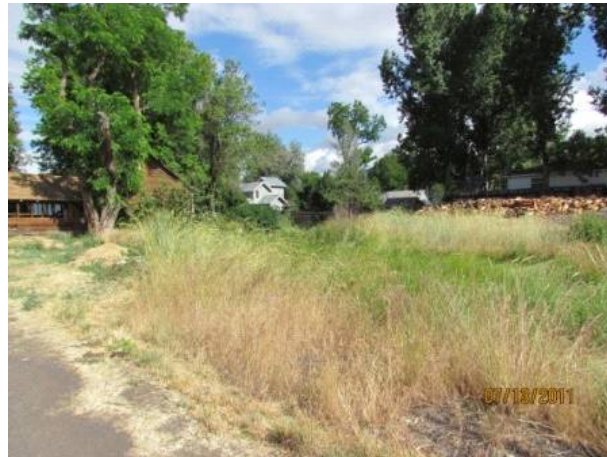
Levee Mile Report Line	6
Start Levee Mile	0.00
End Levee Mile	0.00
Location	
Category	Channels
Item	Vegetation & Obstructions
Downstream from Adin Street. Minimal growth in channel.	
rduffey_c_20110801_038.jpg

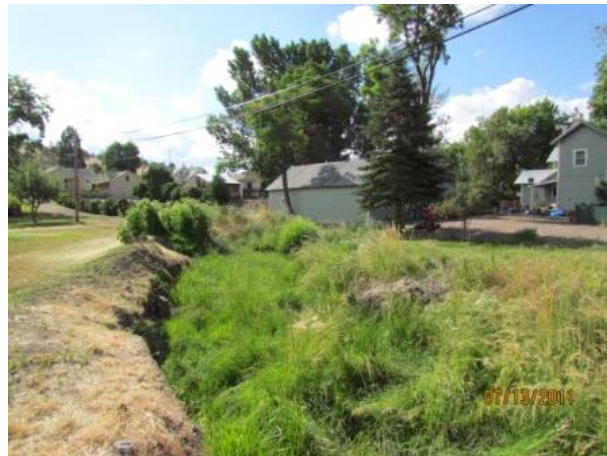
Levee Mile Report Line	11
Start Levee Mile	0.00
End Levee Mile	0.00
Location	
Category	Channels
Item	Vegetation & Obstructions
Upstream from Main Street. Minimal growth in channel.	
rduffey_c_20110801_039.jpg

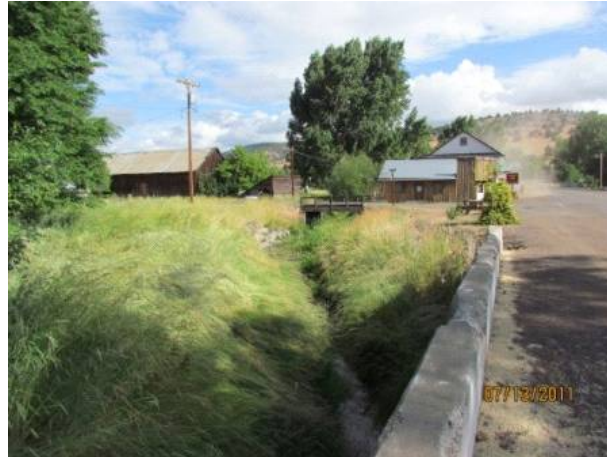
Levee Mile Report Line	16
Start Levee Mile	0.00
End Levee Mile	0.00
Location	
Category	Channels
Item	Vegetation & Obstructions

View of the minimal vegetation in channel.
